--LAKE SHIRLEY DAM --
PHASE I
INSPECTION / EVALUATION REPORT

Dam Name: Lake Shirley Dam
State Dam ID#: 4-9-270-3
NID ID#: MA00455
Owner: Town of Lunenburg
Town: Lunenburg
Consultant: Weston & Sampson Engineers, Inc.
Date of Inspection: July 16, 2009

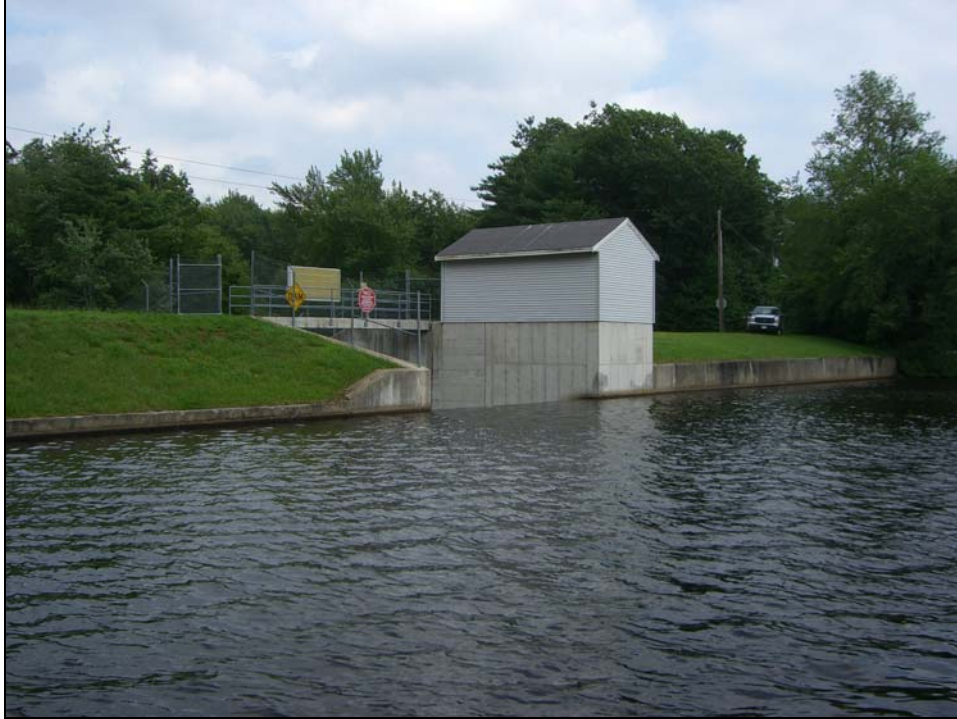
Photo 01 - The upstream slope/face of the dam. The primary spillway, gatehouse, concrete wave walls, and grassed earthen slope are visible in this image. The right abutment is beyond the truck and telephone pole in this image.

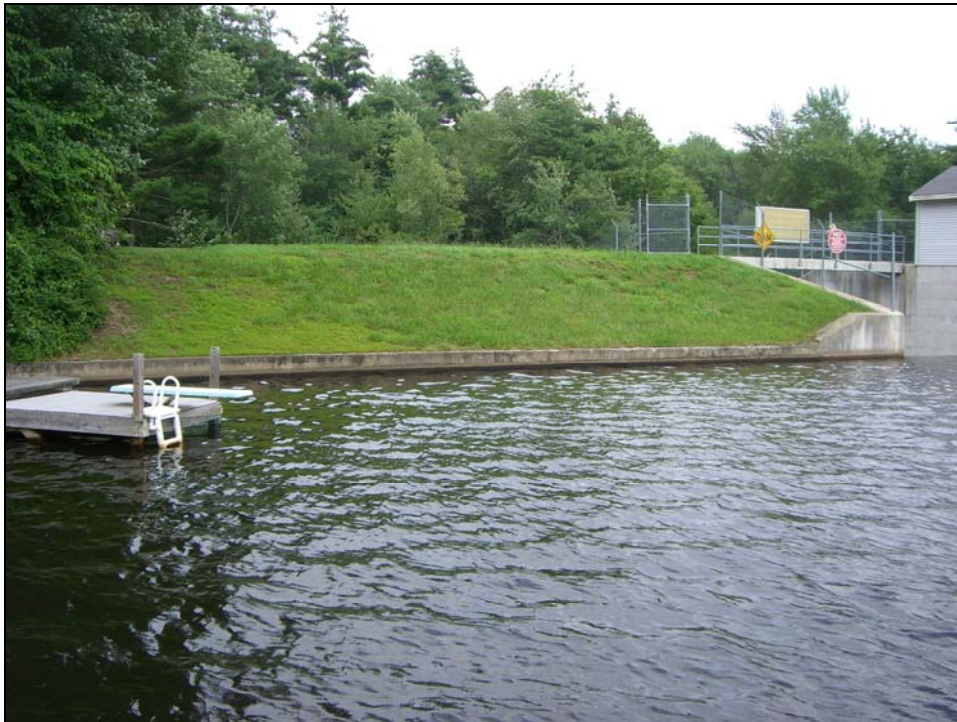
Photo 02 - The upstream slope/face of the dam immediately to the left of the primary spillway. The trees on the upstream slope near the dock in the left side of this image are on private property.

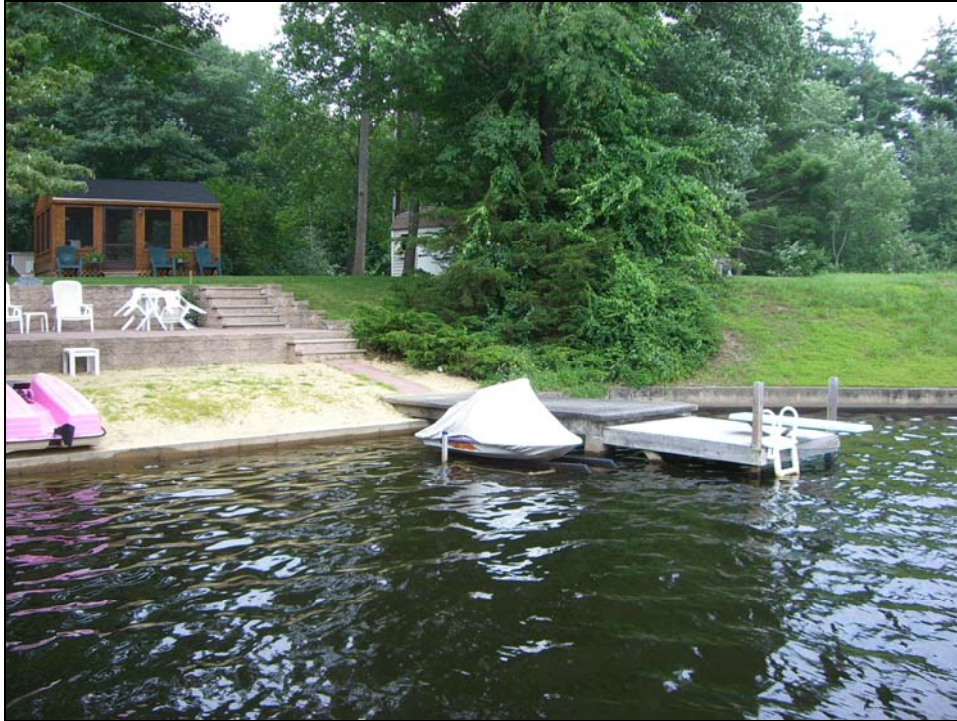
Photo 03 - The upstream slope and crest of the dam near the left abutment. This private home site may have been the site of a former mill. The site is essentially level with the embankment crest shown in Photo 02 and is between 40 ft. wide and up to approximately 120 ft. wide where the site contacts the left abutment.

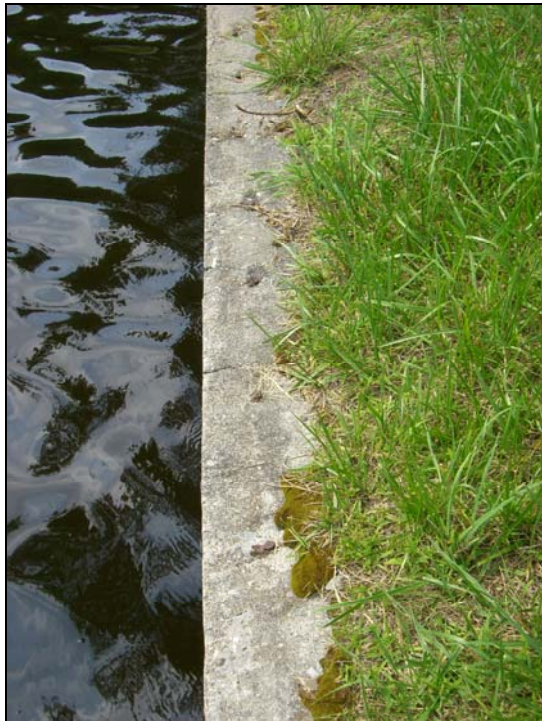
Photo 04 - The top of the wave wall to the left of the primary spillway looking to the left. The tops of cut off vertical steel bars are visible along the top of the wall.

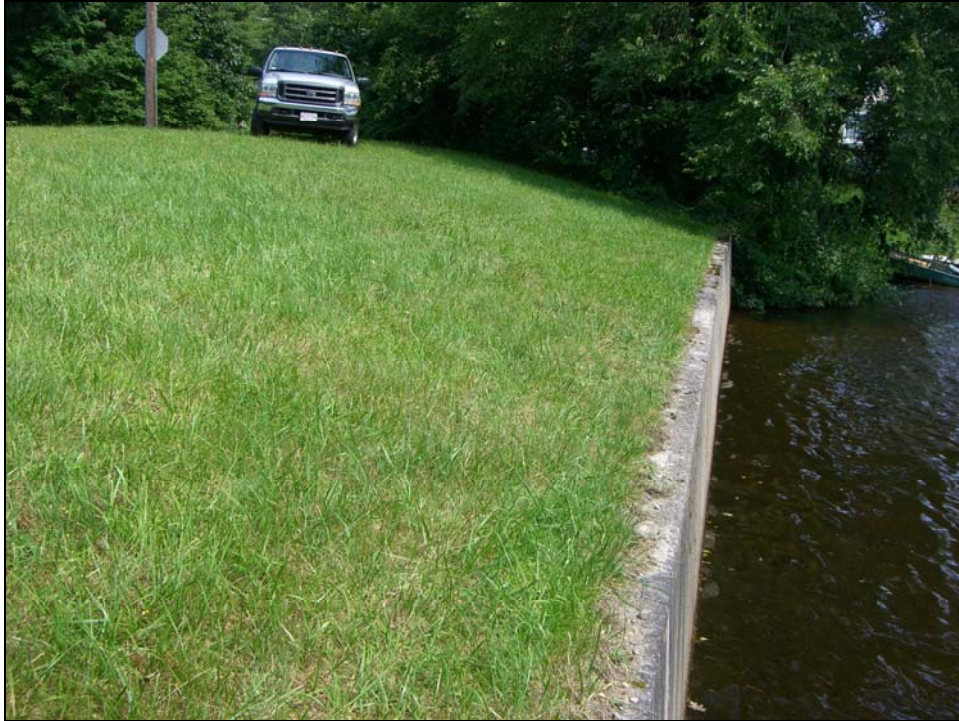
Photo 05 - The upstream slope to the right of the primary spillway. The trees and brush on the upstream slope are on private property. The grassed portion of the slope appears to be well maintained. The right abutment is beyond the truck and telephone pole in this image.

- Remove brush up to 4 in. in diameter at the right and left ends of the upstream wave walls and on the downstream slope near the left abutment (private property). Inspect these areas for any deficiencies not detected during this inspection.

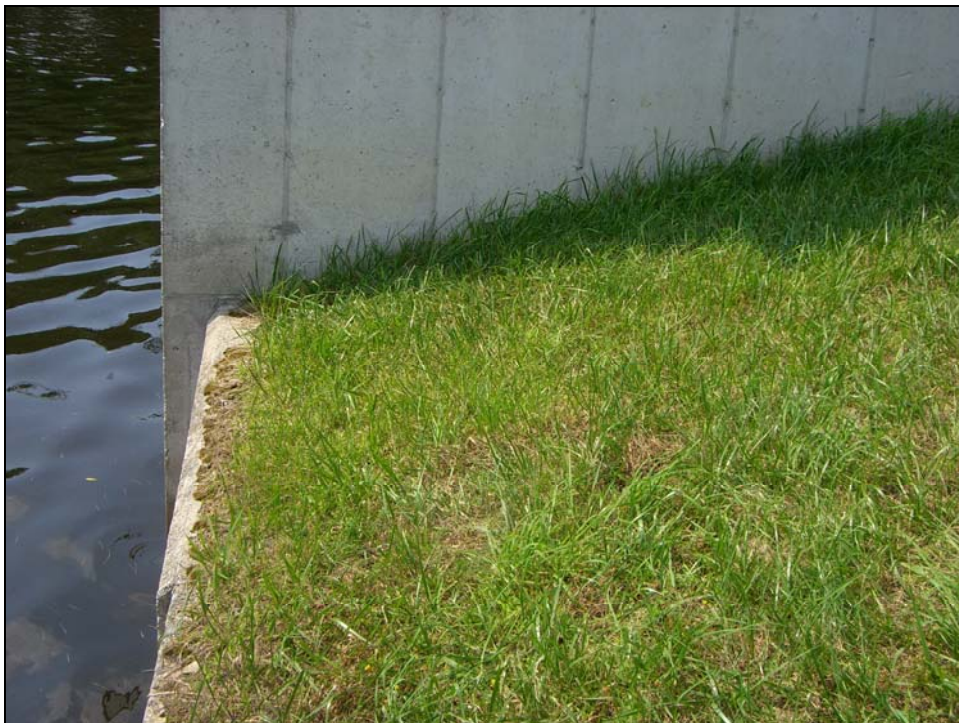
Several vertical cracks in the upstream wave wall were observed as was minor outward movement. Continued monitoring of this condition is recommended. Minor surface spalling and cracking was observed on the training walls, weir, and catwalk bridge, but these conditions appear surficial in nature.

Photo 06 - The upstream wave wall and gatehouse foundation to the right of the primary spillway. Minor outward wave wall movement was observed in this area.

- Remove debris that becomes lodged on the primary spillway weir or in the discharge channel to ensure free flow conditions through the system.
- Monitor the upstream wave walls for vertical cracks and rotation/tilting.

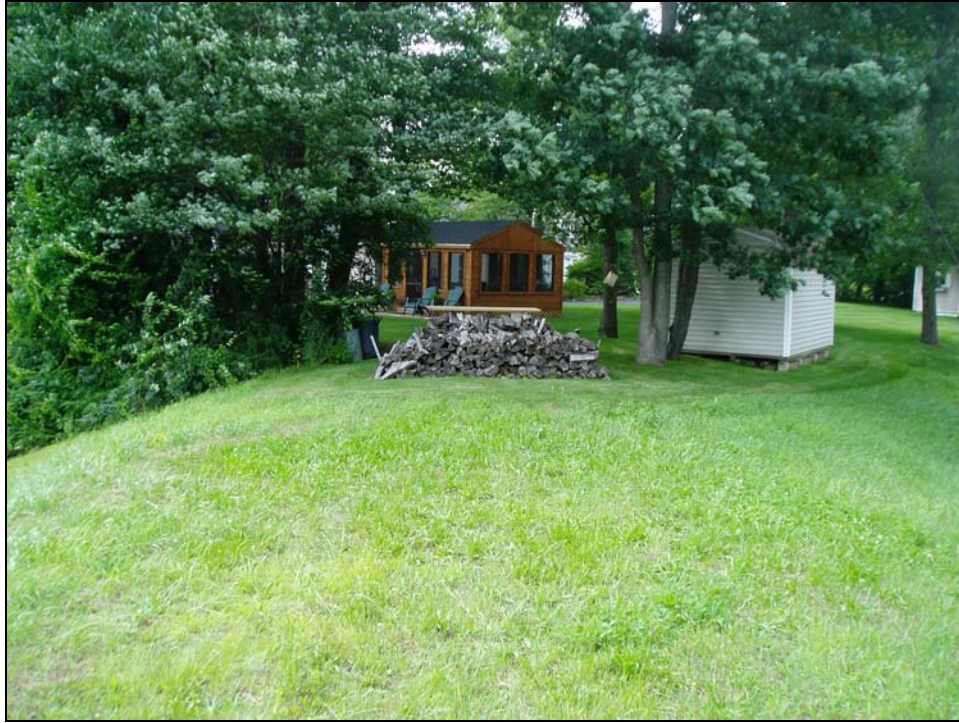
Photo 07 - The crest of the dam looking towards the left from the primary spillway. The left abutment is beyond the structures visible in this image.

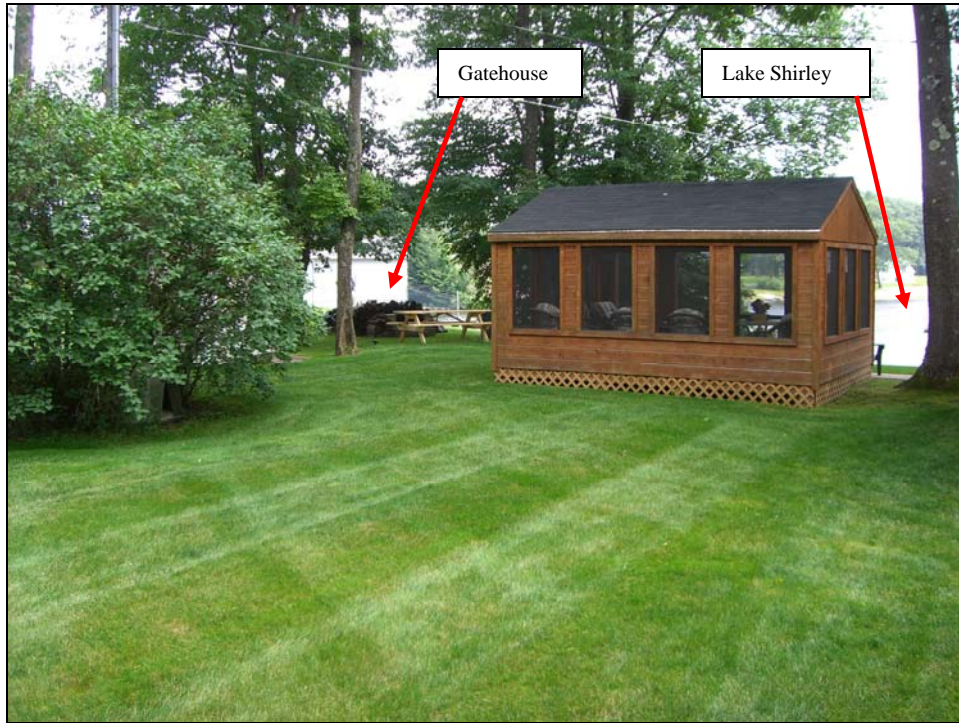
Photo 08 - The dam crest on the private property near the left abutment. Lake Shirley and the gatehouse are visible in the background. The crest is up to 120 ft. wide in this area.

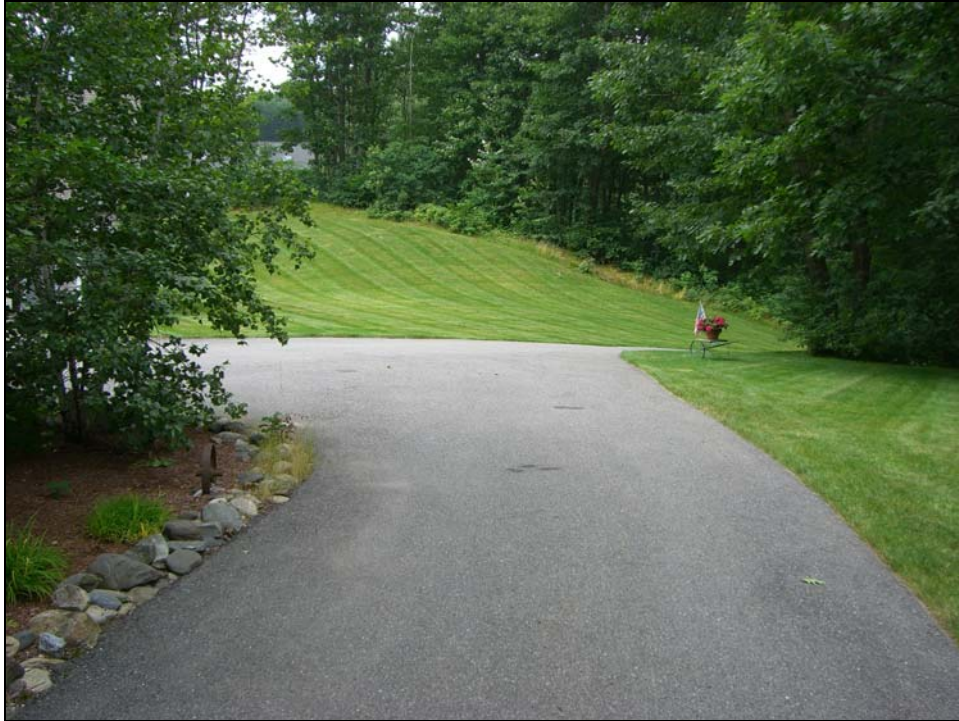
Photo 09 - The left abutment is the toe of the slope beyond the driveway in this image.

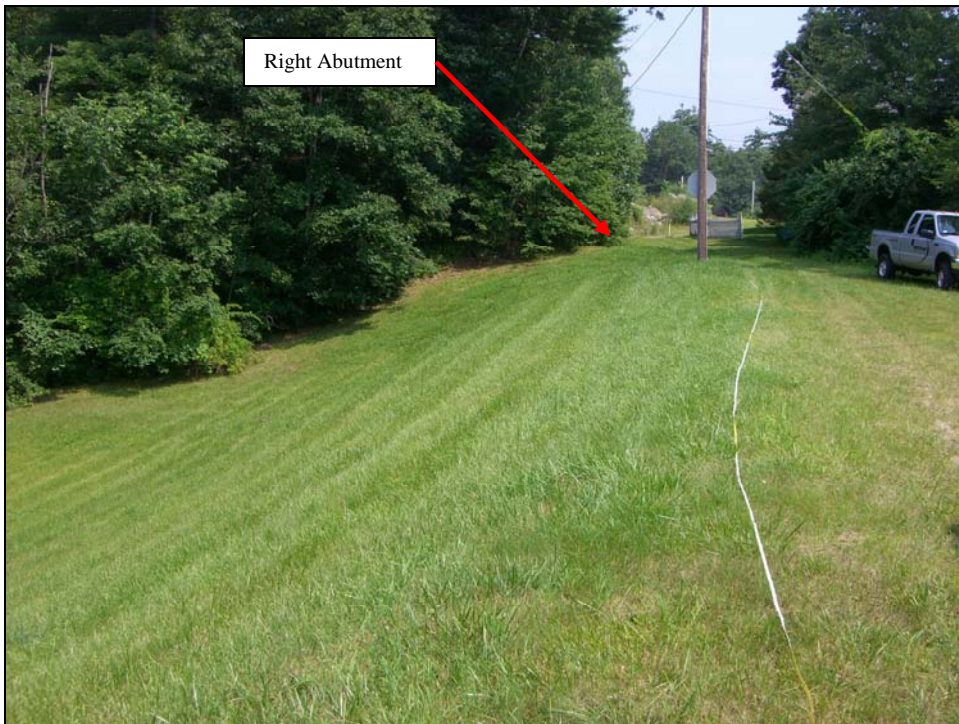
Photo 10 - The crest and downstream slope to the right of the primary spillway looking towards the right abutment. The crest and slope are surfaced with well maintained grass.

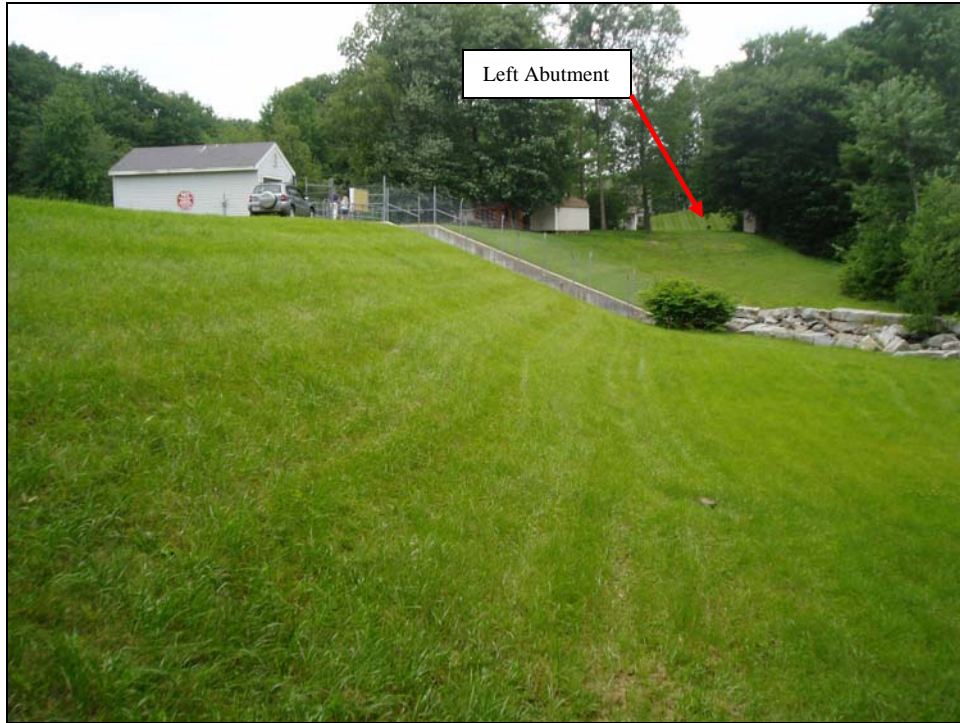
Photo 11 - The downstream slope looking towards the primary spillway from the right abutment area. The slope is surfaced with a well maintained grass cover. The left abutment is at the hill visible in the background of this photo.

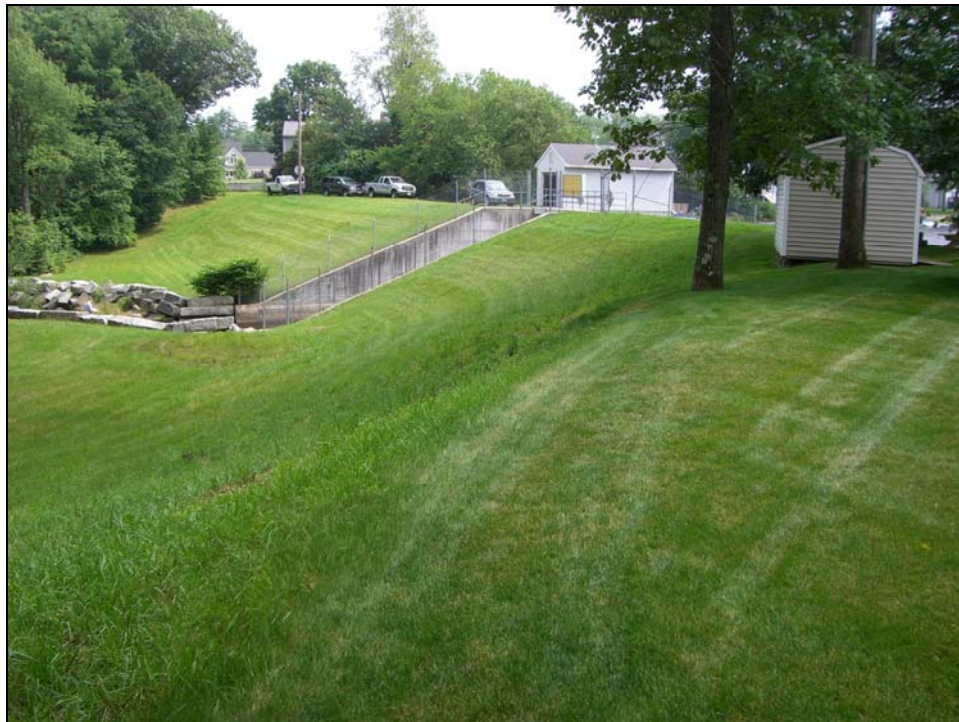
Photo 12 - The downstream slope looking towards the primary spillway from the private property near the left abutment. The grass is well maintained although some weeds were observed in this area.

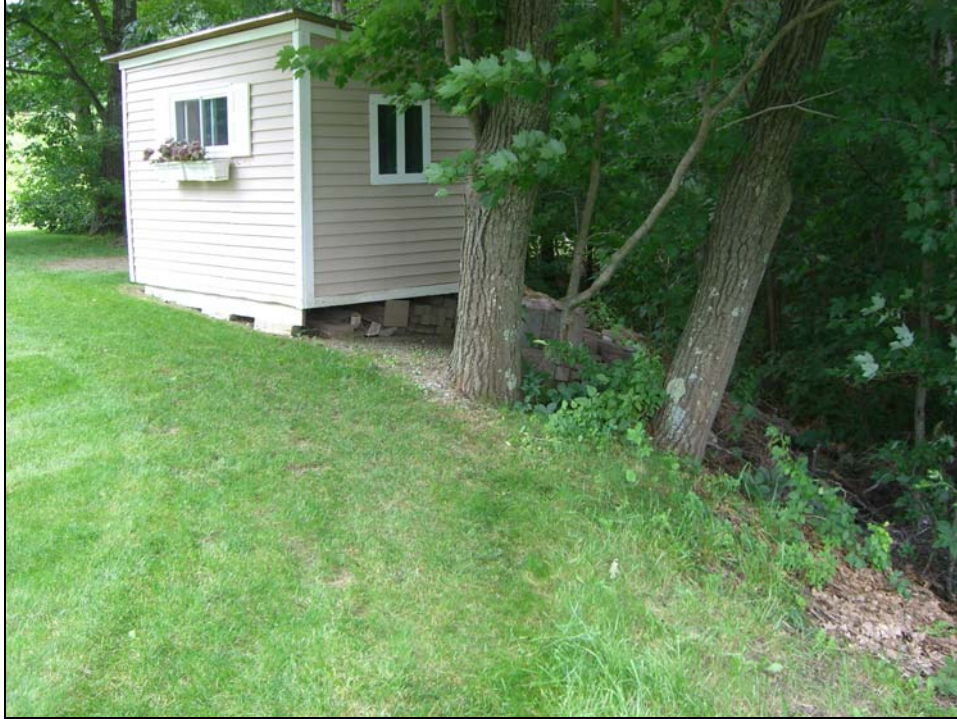
Photo 13 - The downstream slope looking towards the left abutment on private property. The slope near the left abutment is overgrown with trees and brush. However, the embankment crest is up to 120 ft. wide in this area.

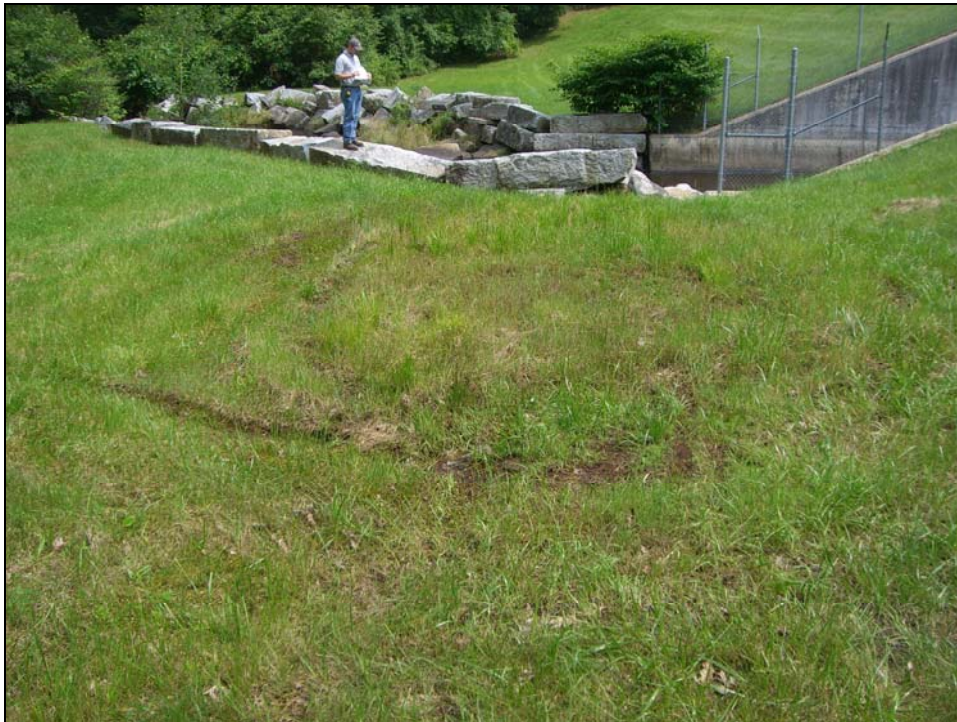
There is a seepage collection system along the downstream toe of the dam. The wet area observed to the left of the primary spillway discharge channel along the toe of the slope could be attributed to a clogged or improperly functioning drain in the system.

Active seepage was not observed along the downstream toe of the slope. The flow through the primary spillway channel prevented the detection of any seepage or leakage into the channel. Standing water and iron staining was observed to the left of the primary spillway at the toe of the slope. This condition could be due to a clogged toe drain seepage collection pipe. Continued monitoring of this area is recommended.

Photo 14 - A wet area was observed at the toe of the downstream slope to the left of the primary spillway. Standing water was observed but no active seepage was detected. There is a toe drain seepage collection system in this area. The drainage pipe of the system may be clogged resulting in this wet area.

- Consult an Engineer to design repairs to fix the toe drain filter collection system in the area of the standing water if the problem worsens based on recommendations above.

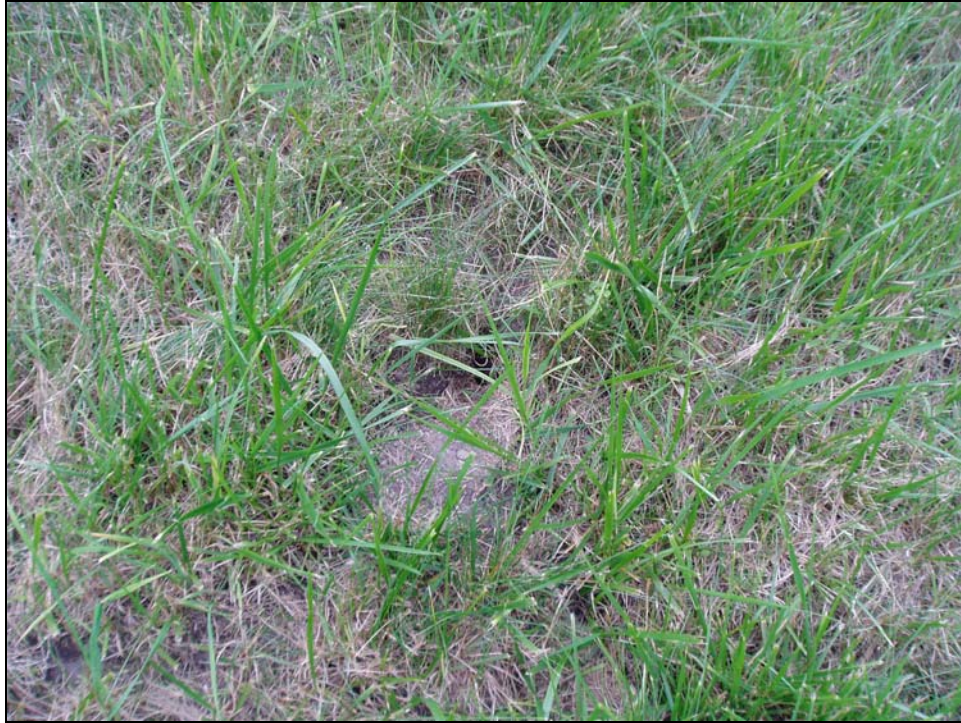
Photo 15 - A small animal burrow observed on the downstream slope to the right of the primary spillway.

- Fill the animal burrows on the dam with compacted granular fill or crushed stone.
- Monitor the surficial spalling and cracking of the primary spillway weir and training walls.

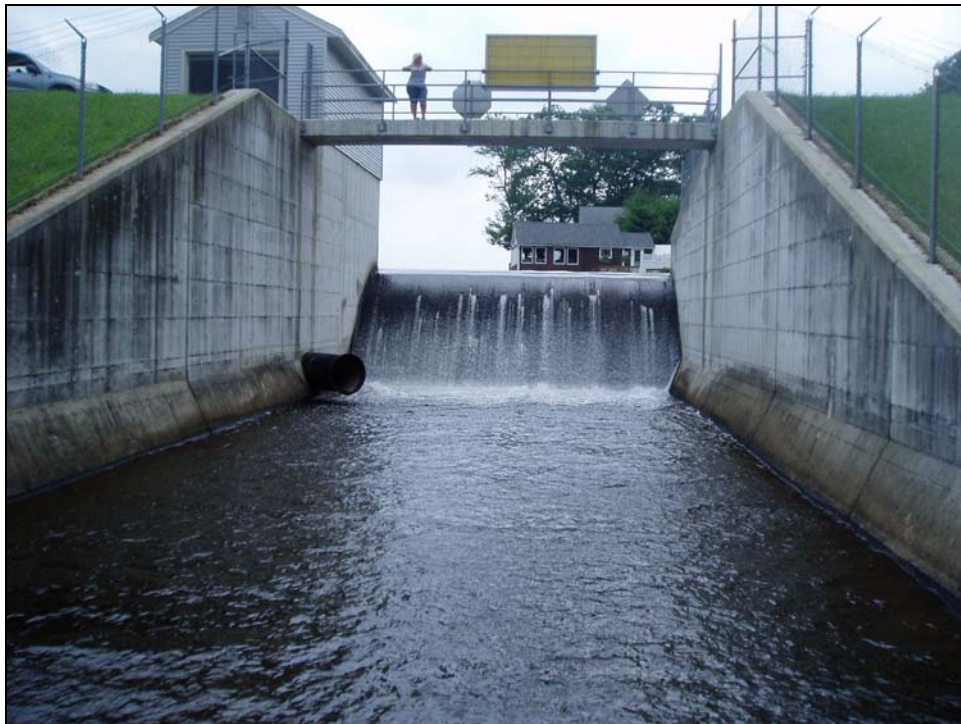
Photo 16 - The primary spillway looking upstream. The ogee weir, concrete catwalk, and discharge channel walls are visible. The minor flow interruptions observed on the weir are small spalled areas. The pipe protruding from the right channel wall (left side in this image) is the discharge pipe from the gatehouse outlet works.

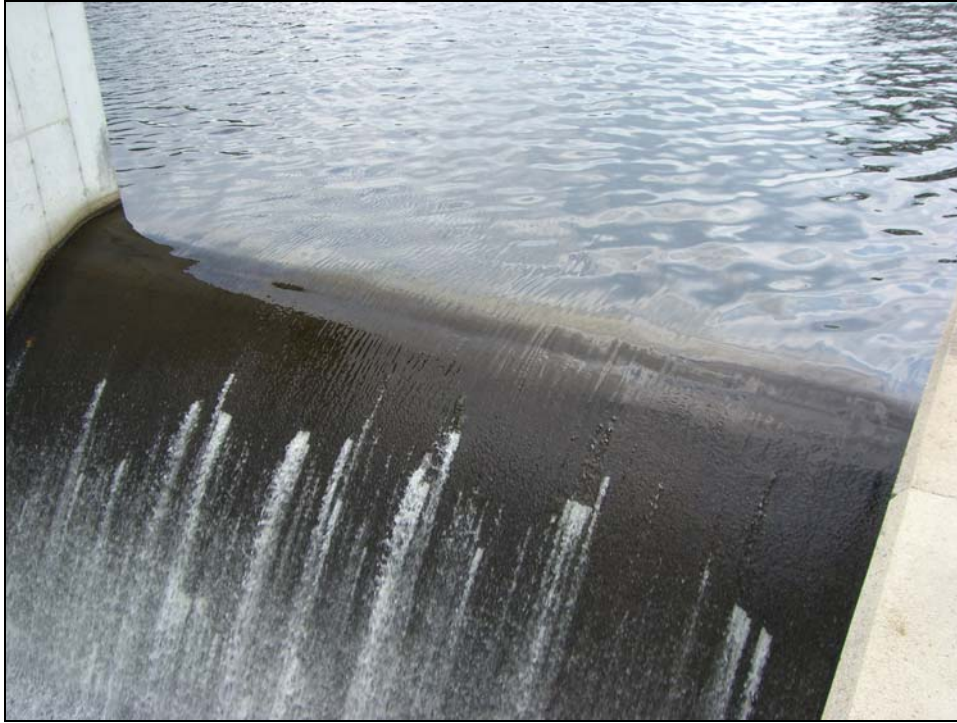
Photo 17 - A close-up of the ogee weir looking upstream. The minor flow interruptions observed on the weir are small spalled areas.

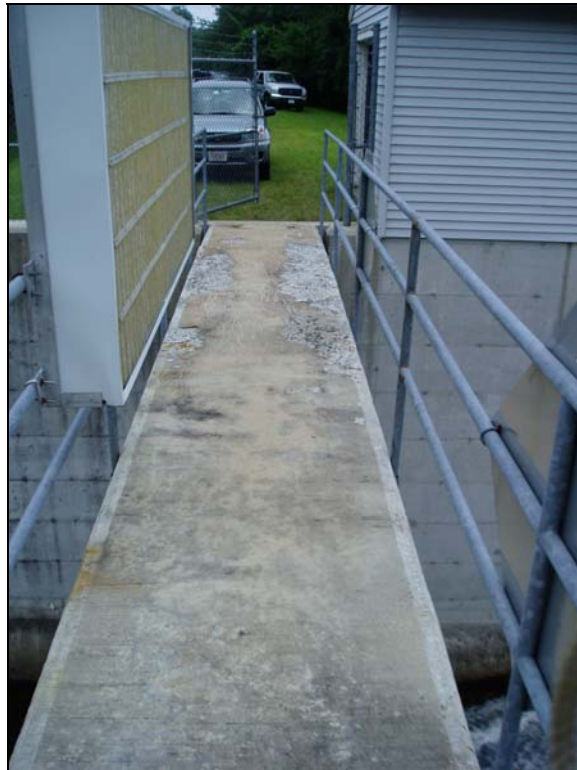
- The maximum depth of flow that Mr. Graves has observed over the primary spillway is approximately 16 in.
- Mr. Graves indicated that the spalled catwalk over the primary spillway could be a tripping hazard.

Photo 18 - The concrete catwalk looking towards the right side of the spillway. Spalling of the catwalk surface was observed.

- Repair the spalled area on the concrete catwalk by removing all loose concrete and applying mortar grout.
- Remove loose soil and organics from the area around the right end of the wave wall. Place a layer of 6 in. riprap bedded in crushed stone overlying filter fabric.

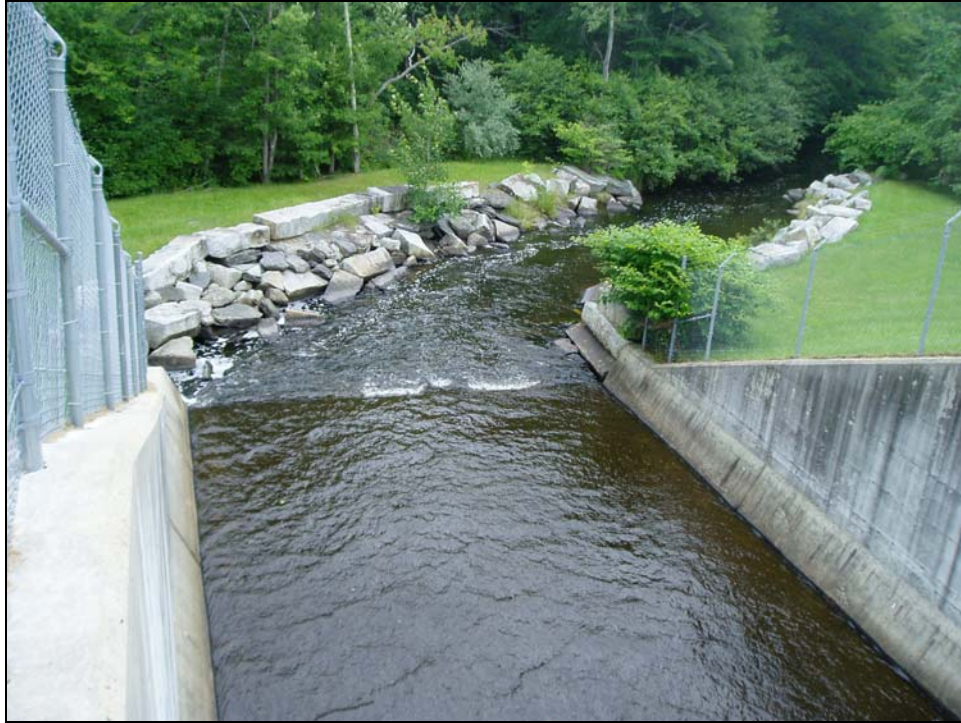
Photo 19 - The spillway discharge channel from the catwalk.

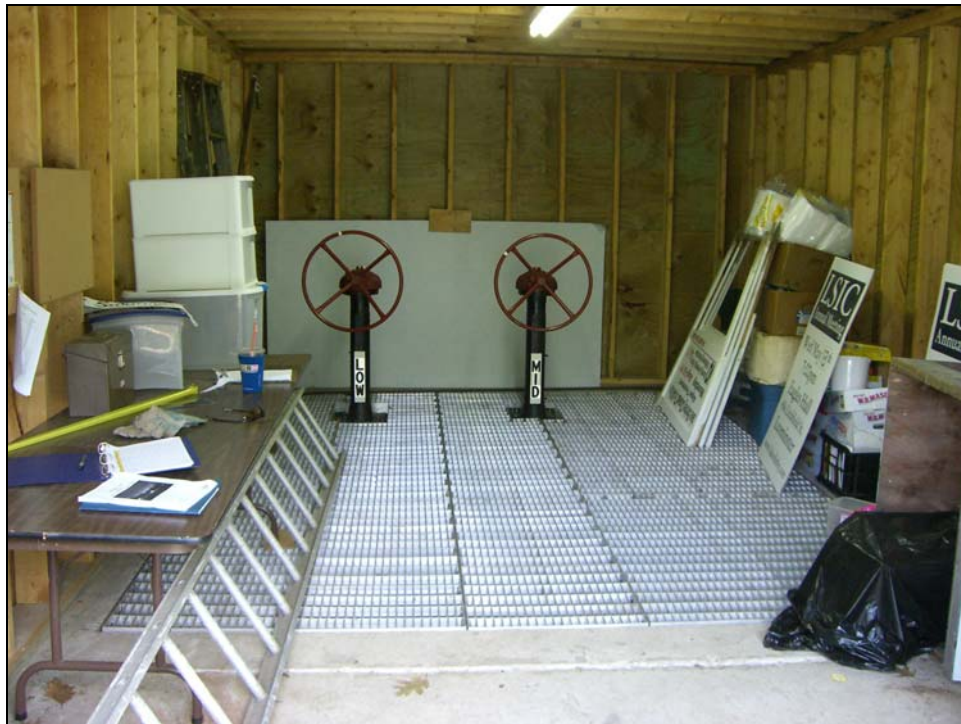
Photo 20 - The interior of the gatehouse structure with LLO and MLO hand wheel gate operators. The gatehouse and outlet works appear to be in satisfactory condition.

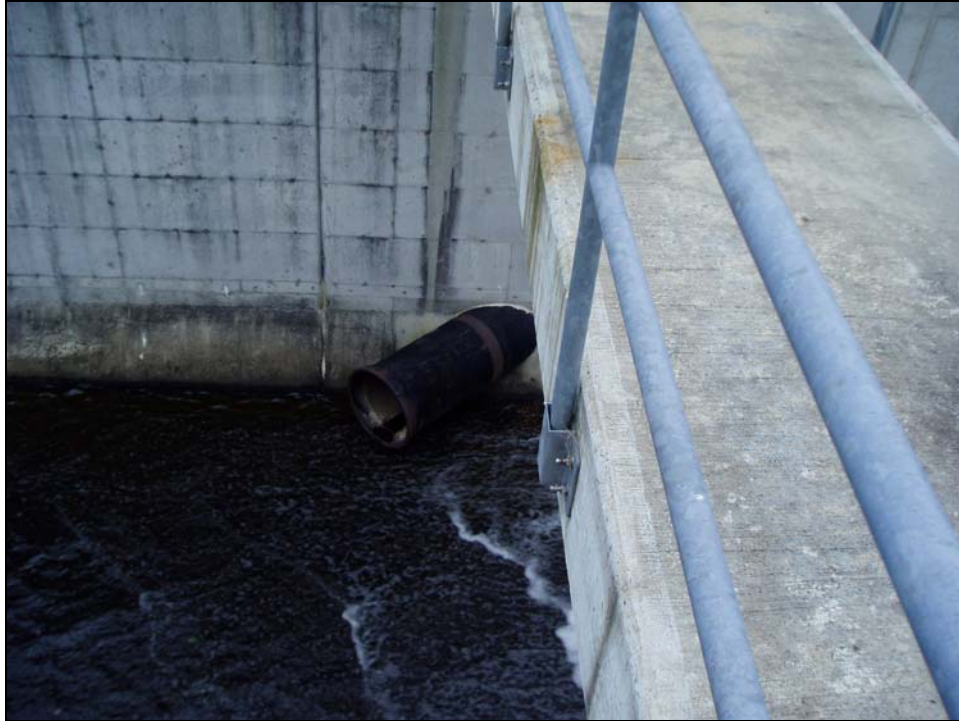
Photo 21 - The discharge pipe of the outlet works protruding from the right wall of the spillway discharge channel. No seepage or leakage was observed.

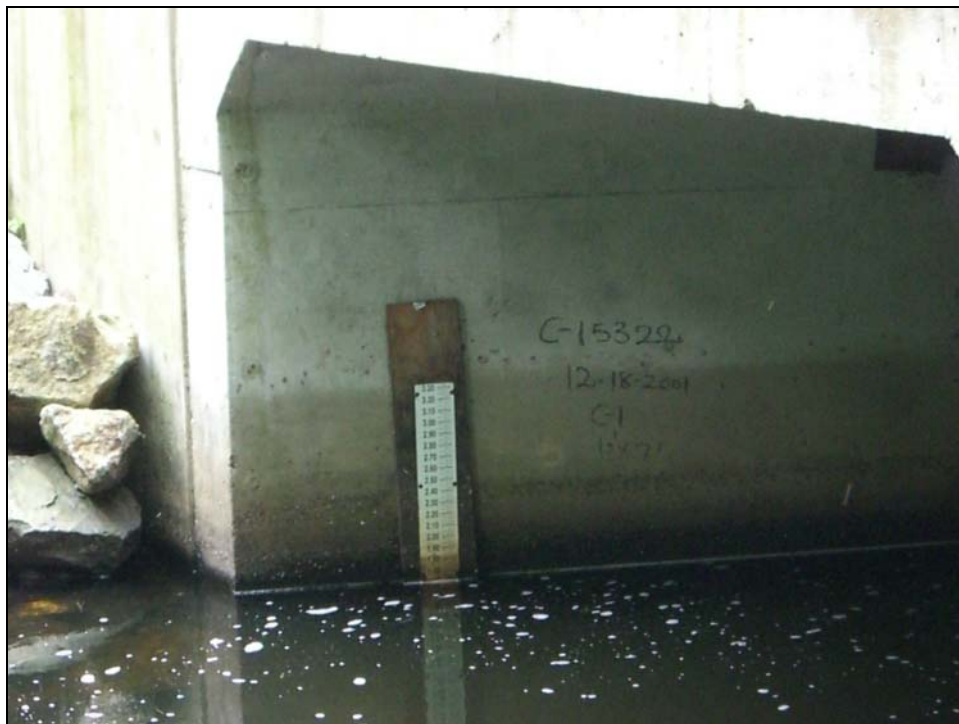
Photo 22 - The staff gauge located at the Catacunemang Road Bridge downstream of the dam.
