**DRAFT
FINAL REPORT TO THE
TOWN OF LUNENBURG
ON
DIAGNOSTIC/FEASIBILITY STUDY
OF LAKE SHIRLEY
LUNENBURG, MASSACHUSETTS
August, 1987**

August 7, 1987

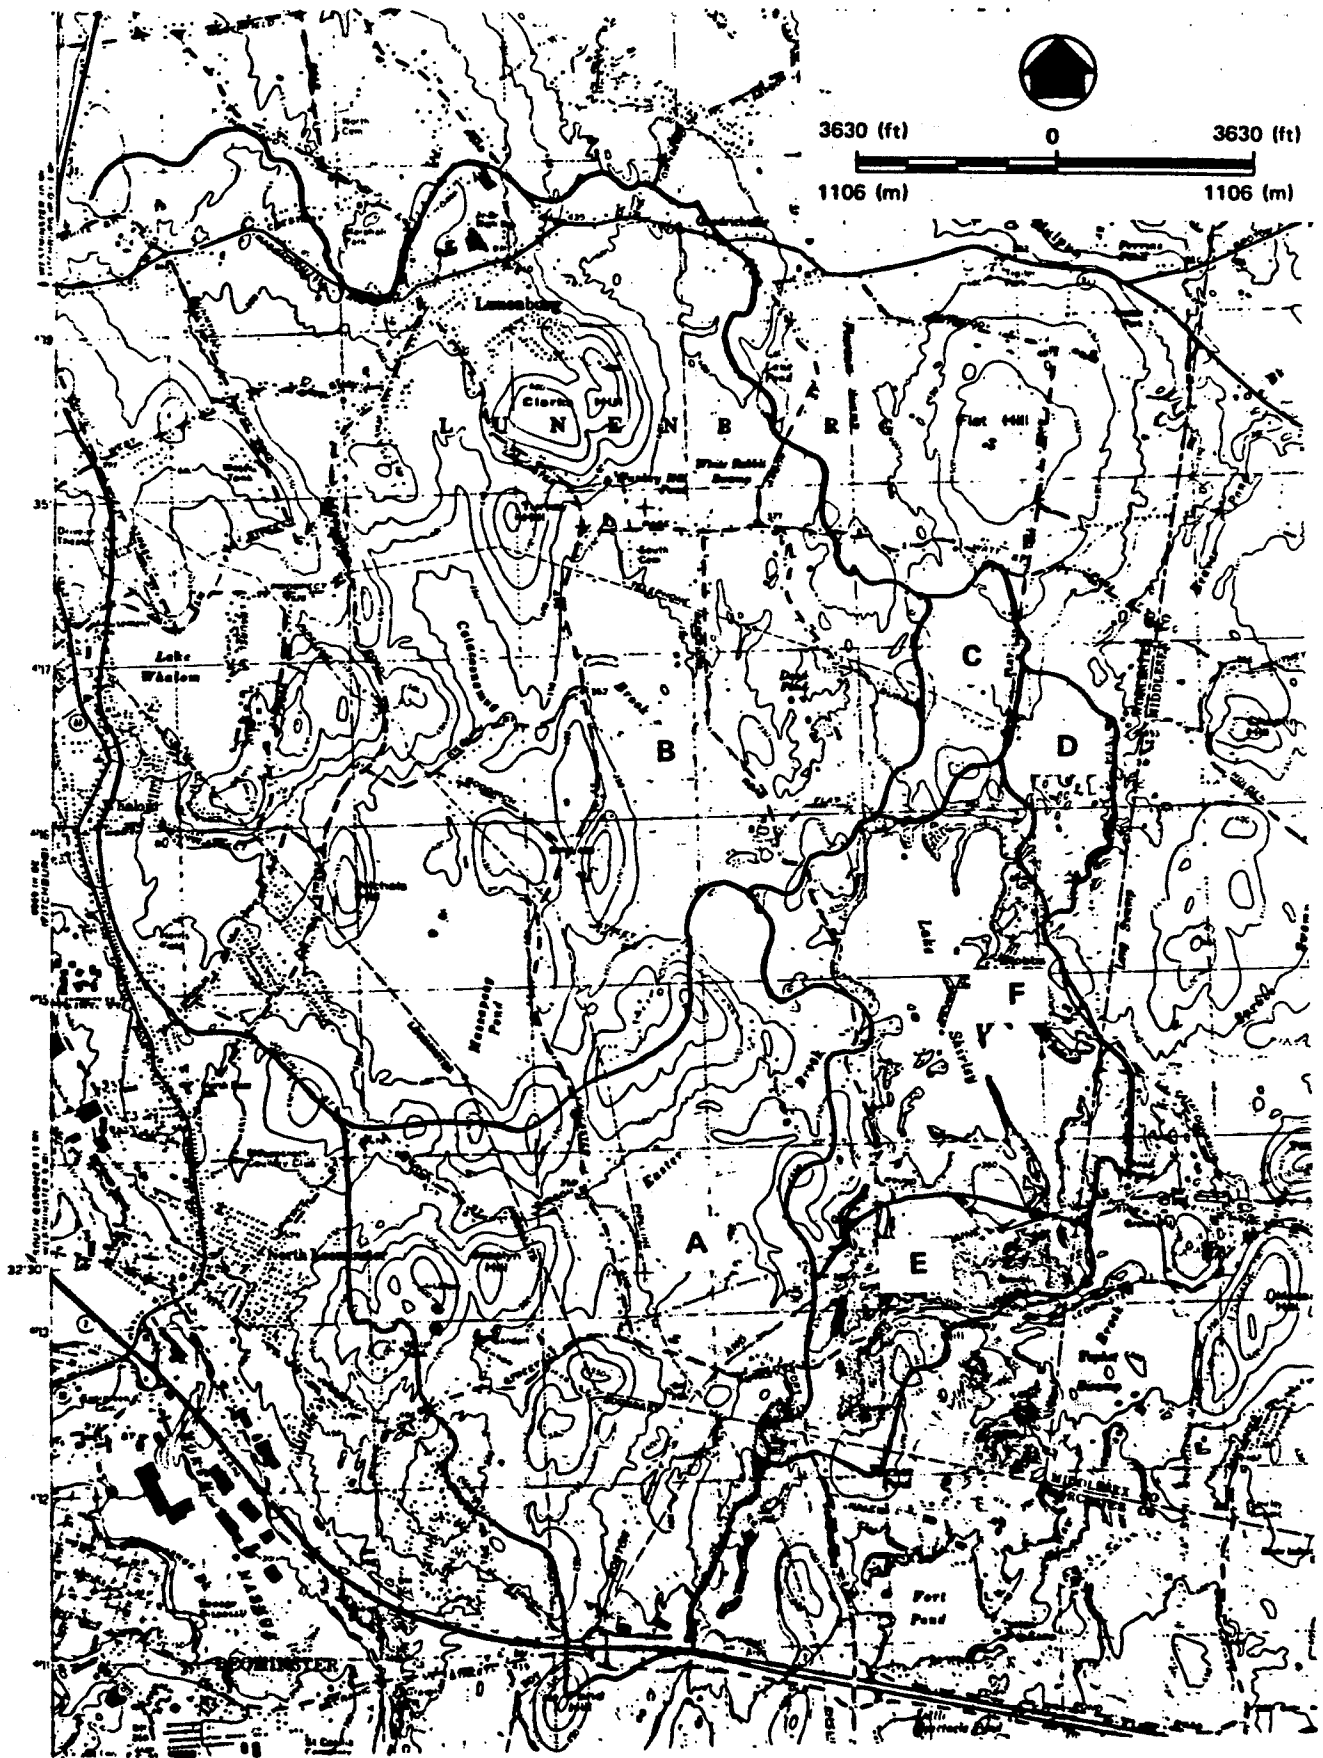
FIGURE 2-2. LAKE SHIRLEY WATERSHED AND SUBDRAINAGE AREAS

Delineation of Drainage Areas. The watershed and sub-drainage basins of Lake Shirley were delineated as part of the diagnostic survey and are presented in Figure 2-2 and Table 2-2. The size of each area was determined from USGS maps

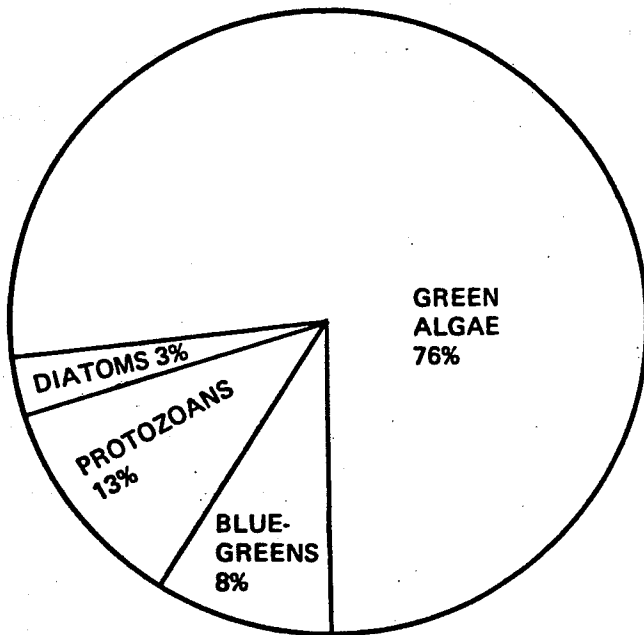
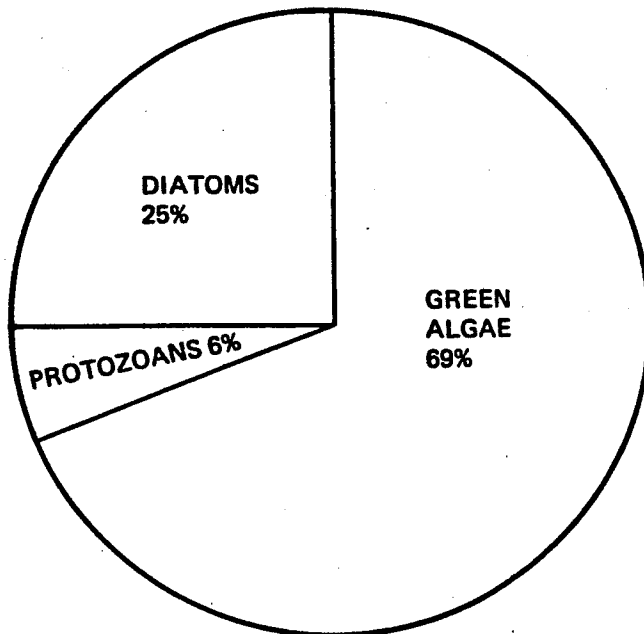
FIGURE 2-8. TAXONOMIC COMPOSITION OF PHYTOPLANKTON IN LAKE SHIRLEY ON JUNE 21, 1977 (MDWPC, 1977)

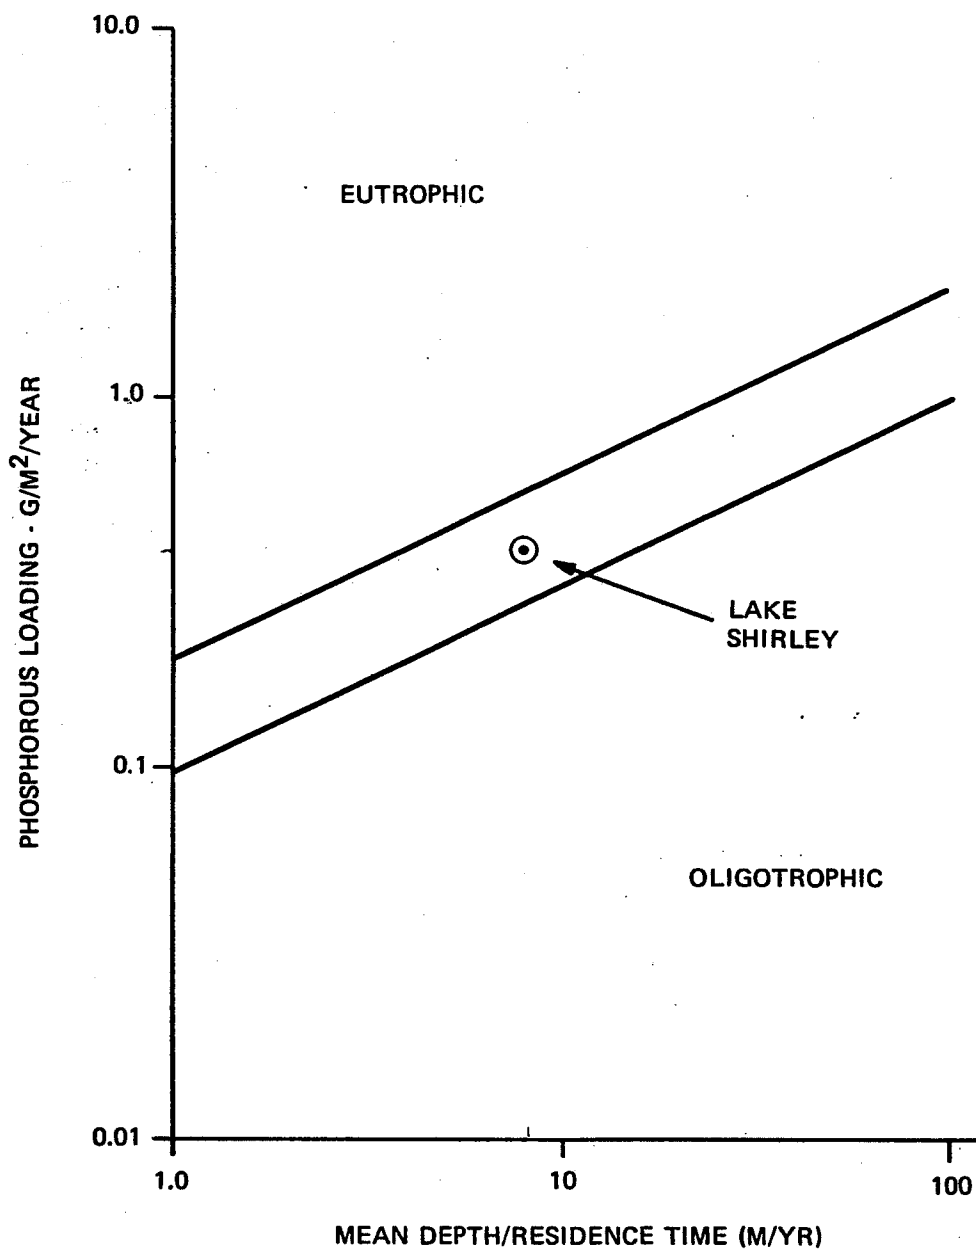
FIG. 4-1. TROPHIC STATE OF LAKE SHIRLEY, LUNENBURG

Given the moderate nutrient loading rates, and low epilimnetic nutrient concentrations and good clarity, it is felt that nutrient inputs are not the major cause of the excessive
